EXTERNAL TRAINING

3D Points Cloud

Our Targets

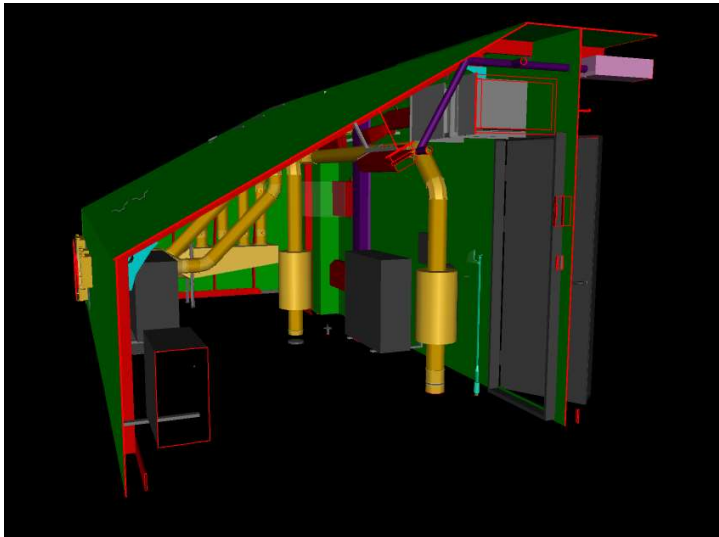
Compare the real position of equipment with the 3D model by 3D scanning

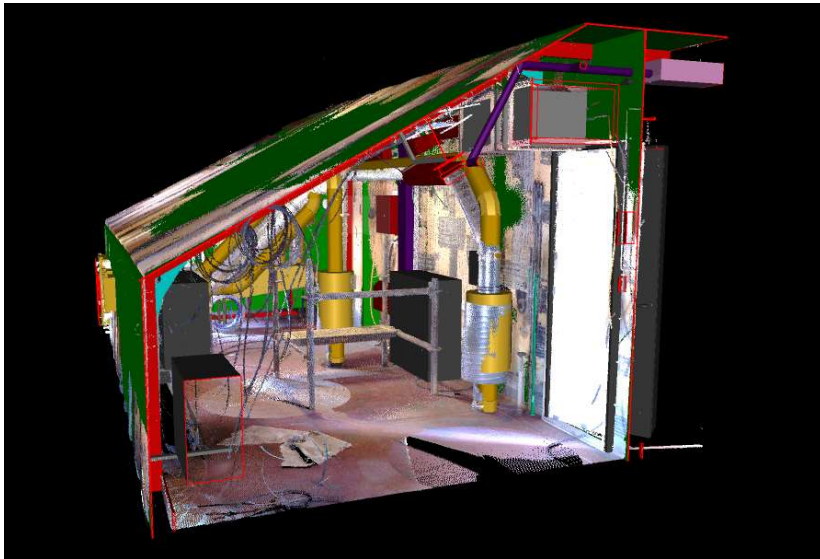
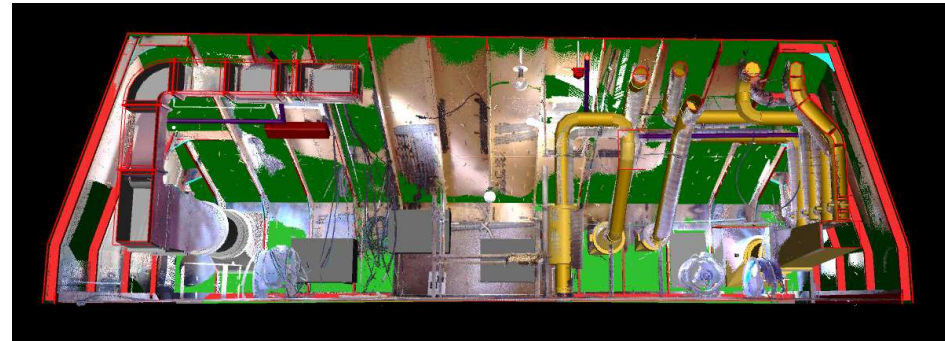
Point cloud over scan

Compare the real position of equipment with the 3D model by 3D scanning

MERGING POINTS CLOUD WITH 3D MODEL BRODOSPLIT TEST

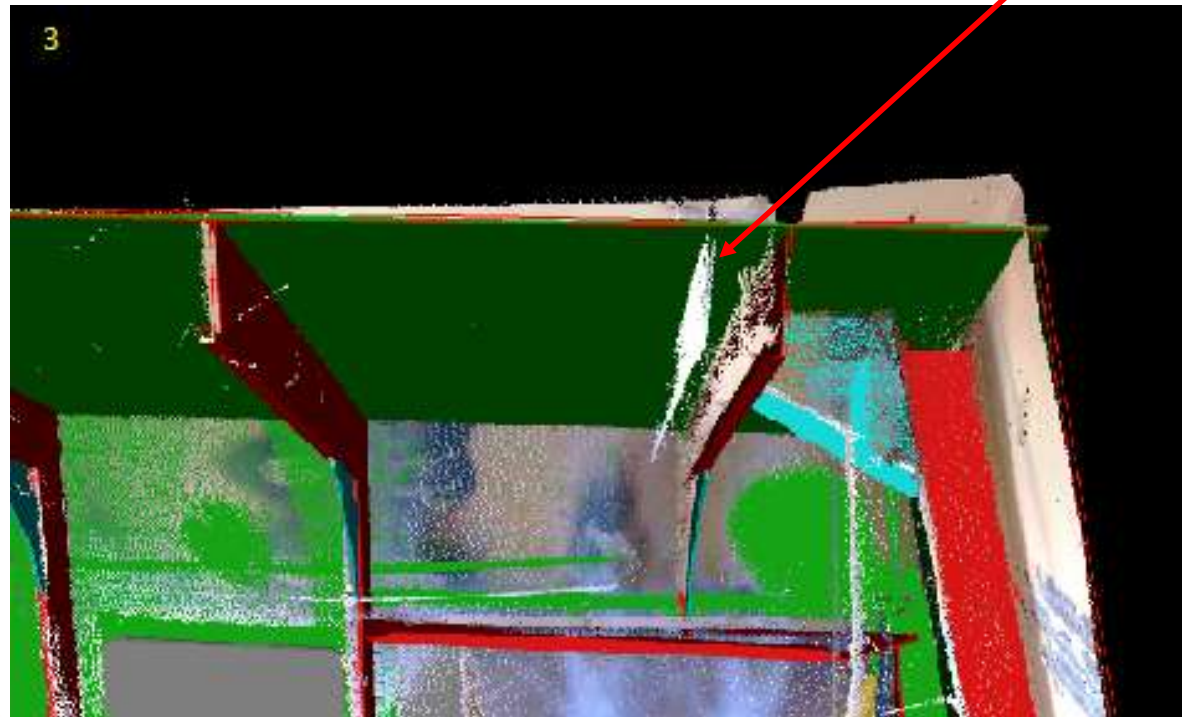
REINFORCEMENT DISPLACEMENT

Compare the real position of equipment with the 3D model by 3D scanning

Point cloud over scan details

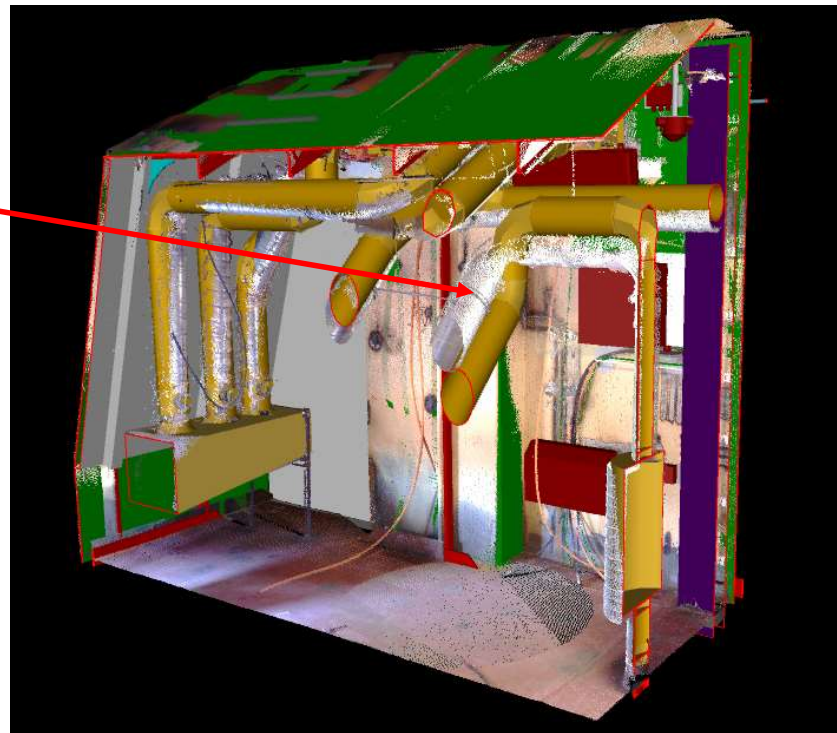
**DUCT NOT IN
DESIGN POSITION**

Compare the real position of equipment with the 3D model by 3D scanning

Point cloud over scan details

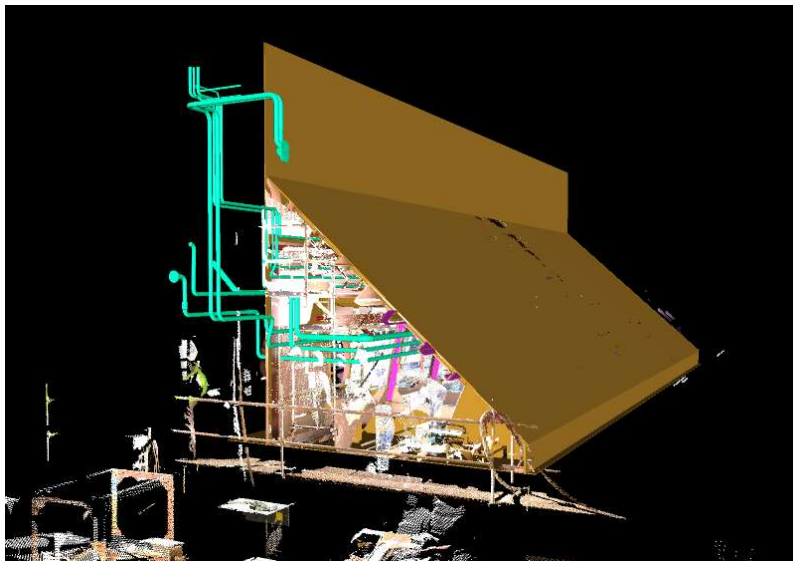
Visual method (Navisworks)

Compare the real position of equipment with the 3D model by 3D scanning

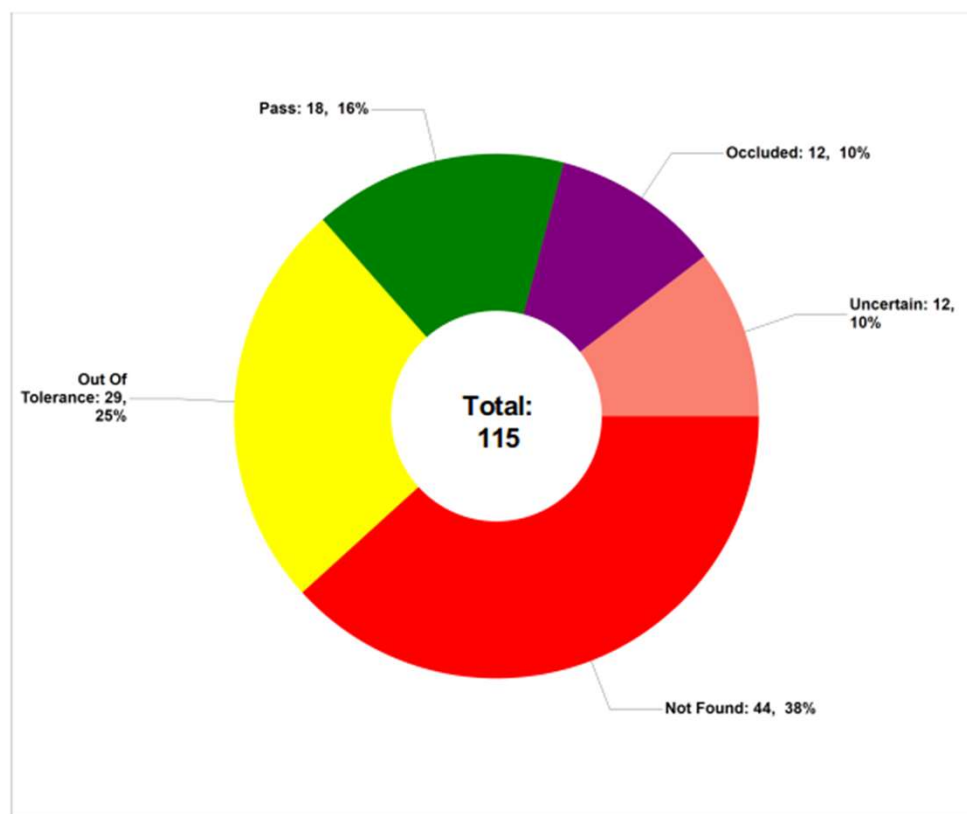
VERITY REPORT SUMMARY

Project:
Brodo_16.11

Analysis:
Van001_2021.11.16

Processing Time:
0:06:19.34 (h:m:s)

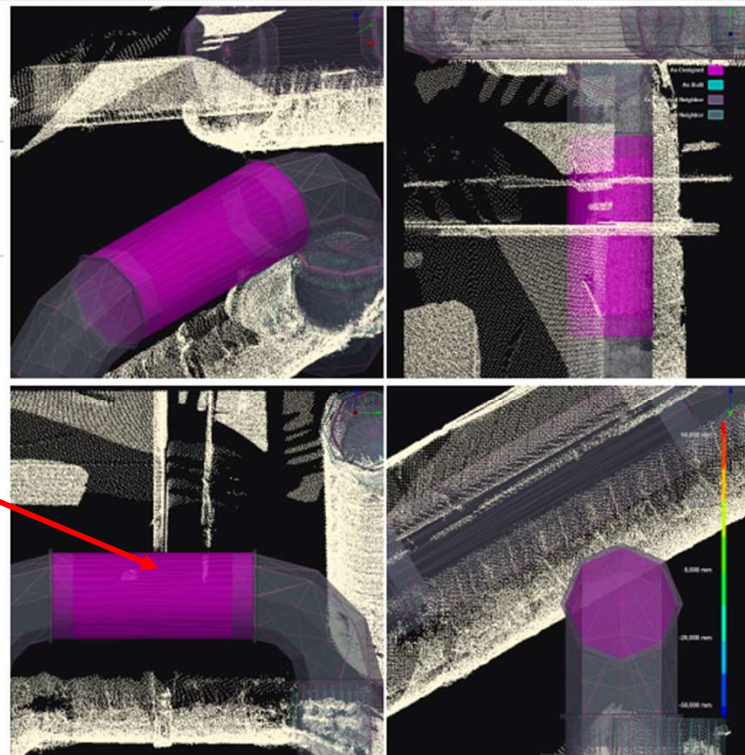
VERITY REPORT
IMAGE LINK
PIPE MISSING

Report Date: 16/11/2021
 Item 102: TUBE 3 of BRANCH /543-5712E.E07.101spiro/B1 || Grupo
 Not Found: N/A - Tolerance: 50,000 mm

Location:
 X: 39.799.999 mm
 Y: 1.146.392 mm
 Z: 23.792.286 mm
 GUID:
 c2c6d4d3-cea0-46e3-89b9-486f525d7d3a

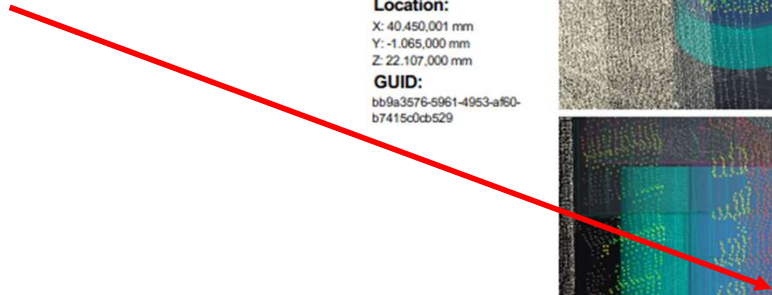
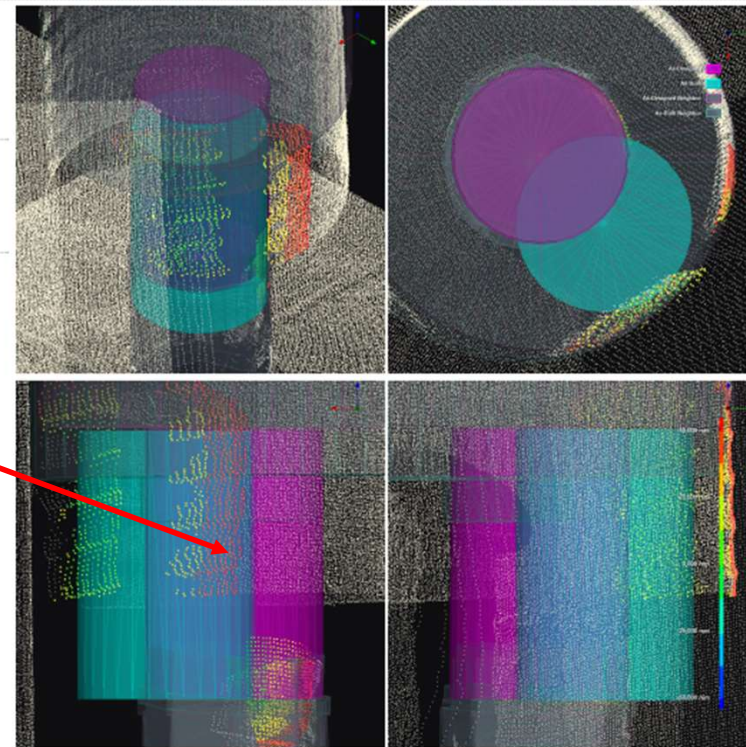
[VERITY REPORT](#)
[IMAGE LINK](#)
[PIPE IN](#)
[DIFFERENT](#)
[POSITION](#)

Report Date: 16/11/2021
 Item 098: TUBE 1 of BRANCH /543-5712E.E08.101spiro/B1 || Grupo
 Installed: Out Of Tolerance - Tolerance: 50,000 mm

Location:
 X: 40.450,001 mm
 Y: -1.065,000 mm
 Z: 22.107,000 mm
 GUID:
 bb9a3576-6961-4953-a160-
 b7415c0cb529

Total	Maximum Translation						Rotation (degrees)		
	Vertical	Horizontal	X Axis (+/-)	Y Axis (+/-)	Long Axis	Cross Axis	From Vertical	Horizontal	Twist (Sectional)
85.560 mm	-0.607 mm	85.558 mm	61.976 mm	59.321 mm	-0.607 mm	85.558 mm	0.313°	0.000°	0.076°

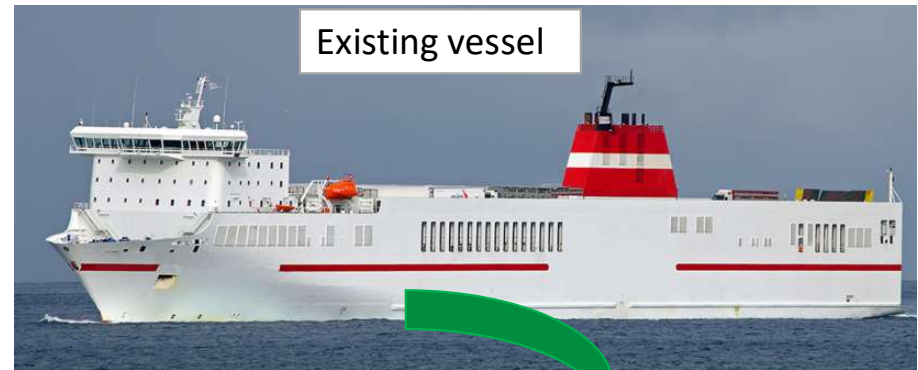
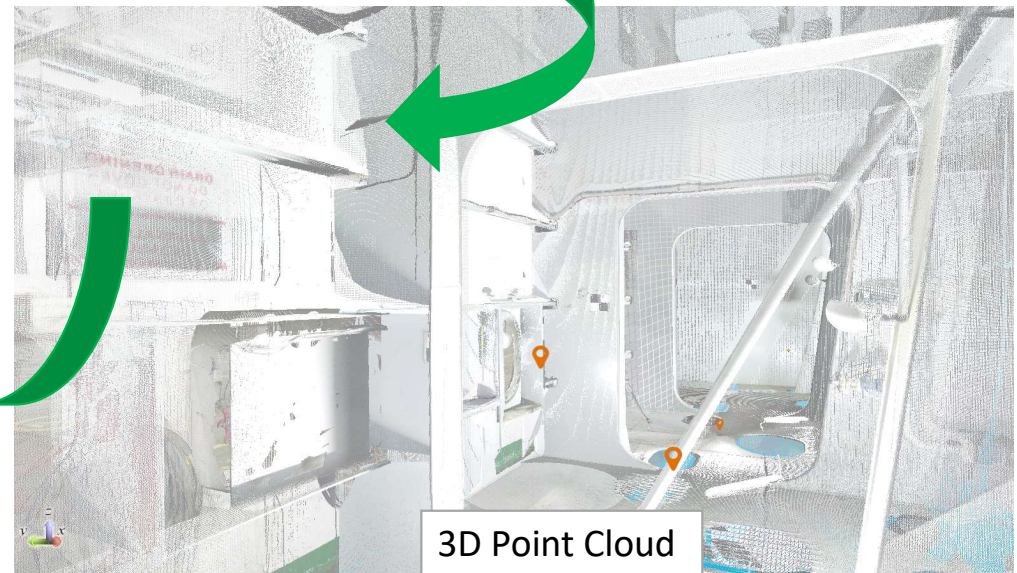
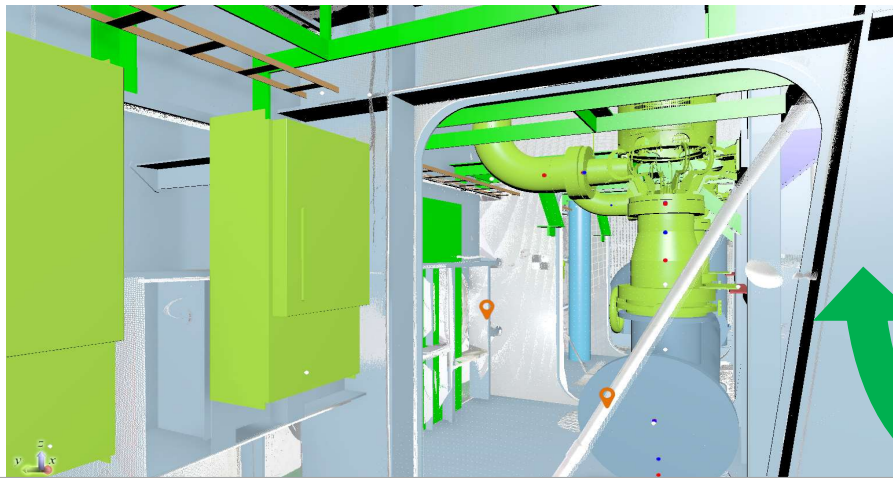
1. Existing Vessel
2. 3D points cloud of the vessel
3. Model based on the 3D points cloud
4. Modification of existing elements or addition of new ones

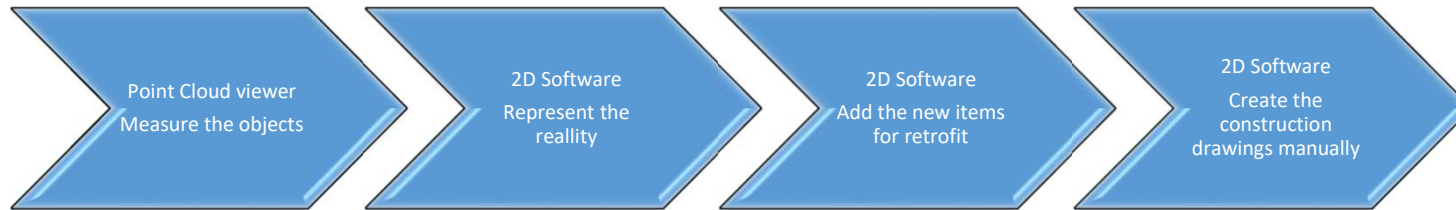
Points cloud viewer + 2D software

- Measurements from an scan viewer (3-coordinates X,Y,Z) to place the elements in the different views of the drawing.
- Position the above measurements in the different views to obtain the initial drawing to start the retrofitting.
- Once the existing is represented, the modifications necessary for retrofitting are added and the construction drawings are created manually.

The accuracy of this method is not very high

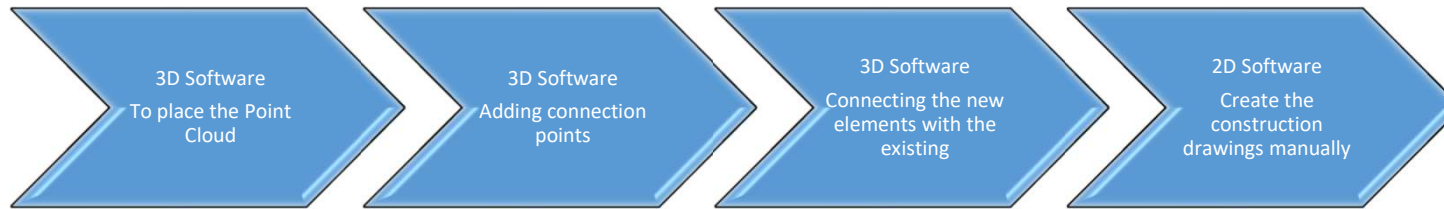
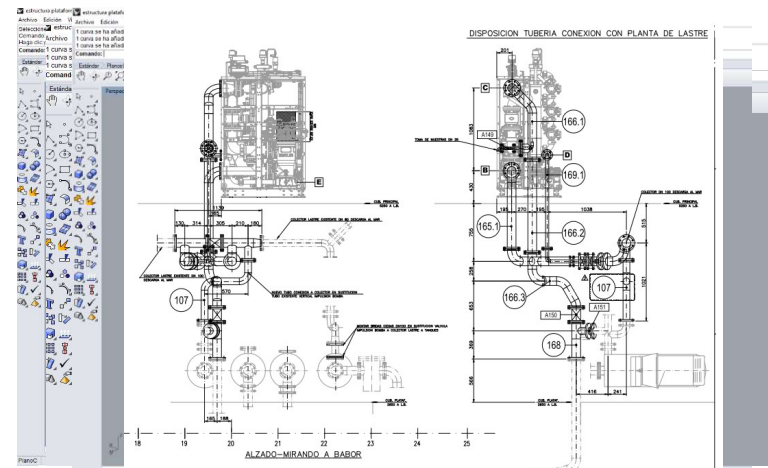
Point cloud viewer + 3D generic software

- Import points cloud into the 3D software.
- Adding new elements needed to begin the work like new equipment or new structures for example.
- Execute the work taking into account the points cloud (in blue new pipelines).
- Obtain manually the construction drawings.

In this case, the advantage is that connections with the existing elements can be seen in 3D and all the clashes that may occur while designing can be detected. Therefore, with this procedure the start of work is faster and the results are more accurate than the previous procedure.

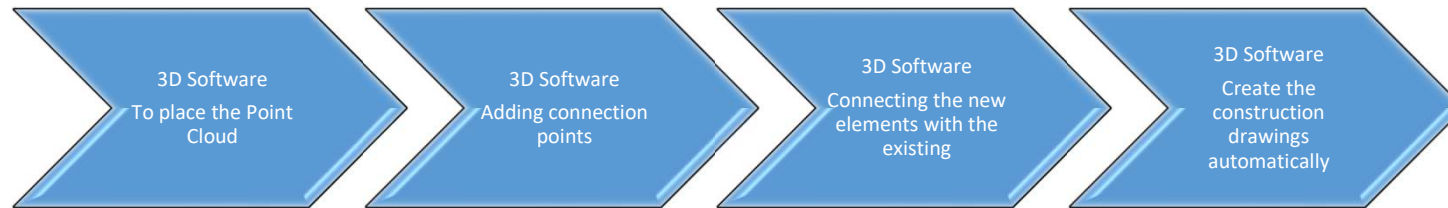
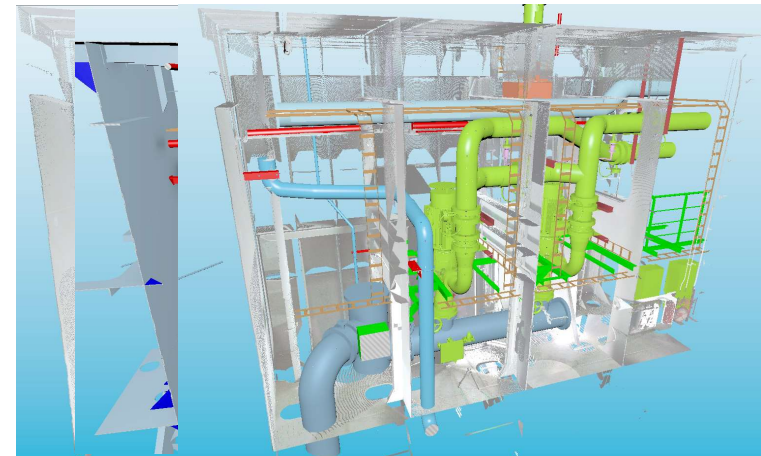
Points cloud viewer + 3D specific software

- Import points cloud into the 3D software.
- The new piping is routed and the necessary structure is modelled, as well as modelling of the cable trays, platforms and position the new equipment.

In this case, the advantage is the software since is an specific software to the shipbuilding industry, the tools for the modelling of pipes, structure, etc. are adapted and their use is much faster and easier to perform.
